Technical Note

title: ANACAPA ISLAND SPLIT PIPE INSPECTION OF
JUNE 1977 AND APRIL 1978

author: W. R. Tausig and R. L. Brackett

date: September 1978

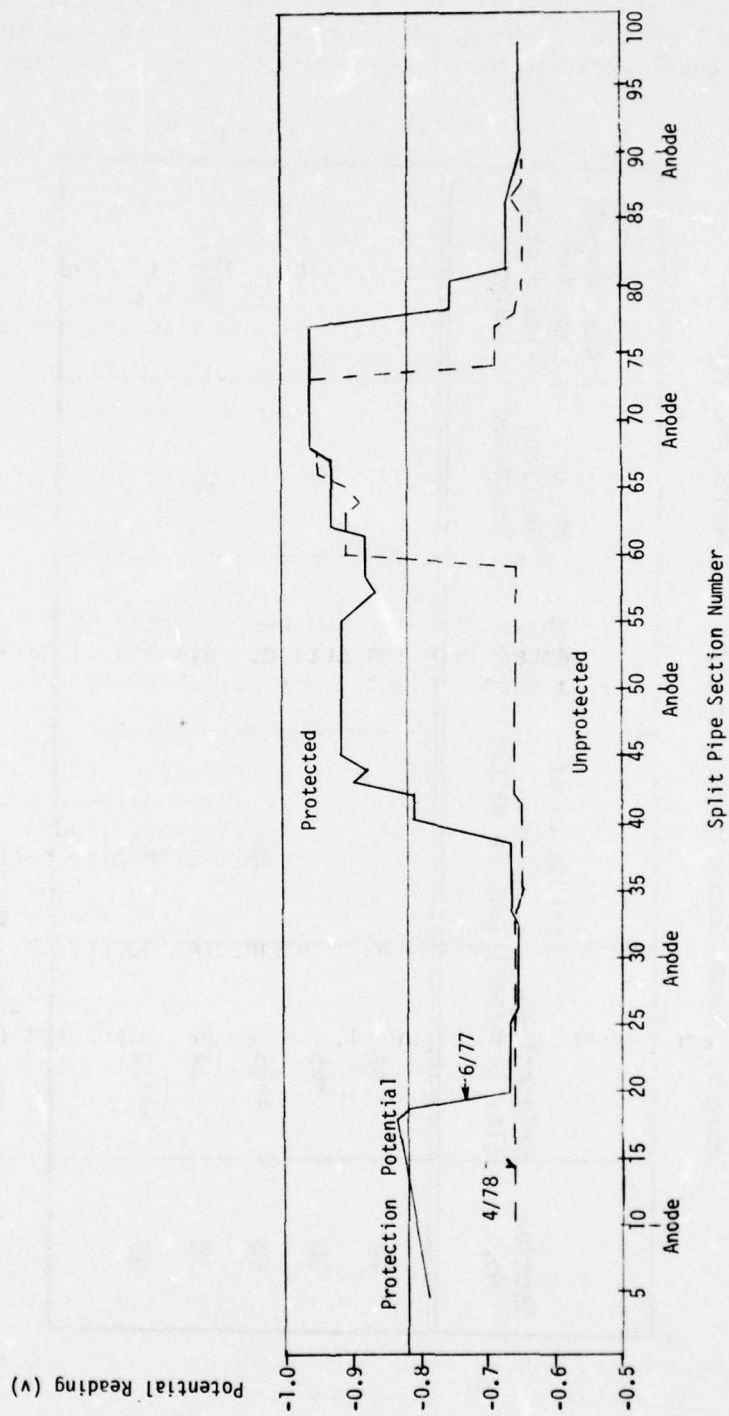
Figure 1. Cathodic Protection Potential

Galvanic potential readings were taken with an underwater voltmeter. The results are presented in Figure 1. Note that pipe sections 43 through 77 are the only sections cathodically protected. The remaining pipe sections are unprotected due to the numerous broken jumper and anode cables.

Galvanic potential readings were again obtained over the entire pipe installation. Results of these data are included in Figure 1. Note that due to further jumper cable and anode failures, only pipe sections 60 through 73 are cathodically protected.

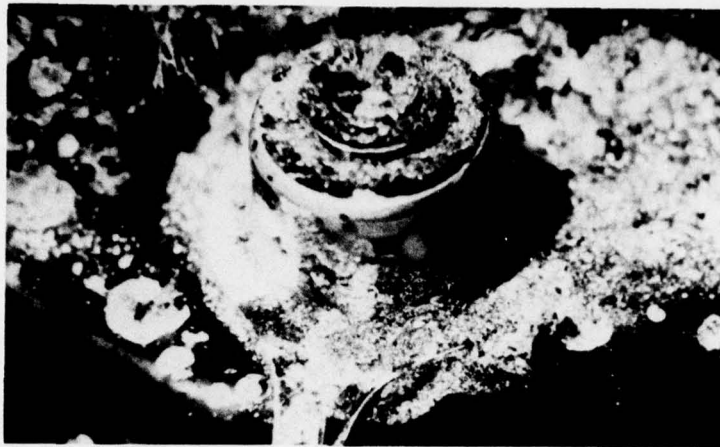
Figure 2a shows an example of a cathodically protected, BOM fastener from the June 1977 inspection. Figure 2b shows an example of a cathodically protected BOM fastener from the April 1978 inspection, after 25 months of submersion. Note in comparing these figures that there is little or no sign of corrosion on the fasteners.

Figure 2a. Cathodically protected fastener from pipe section 57, June 1977.

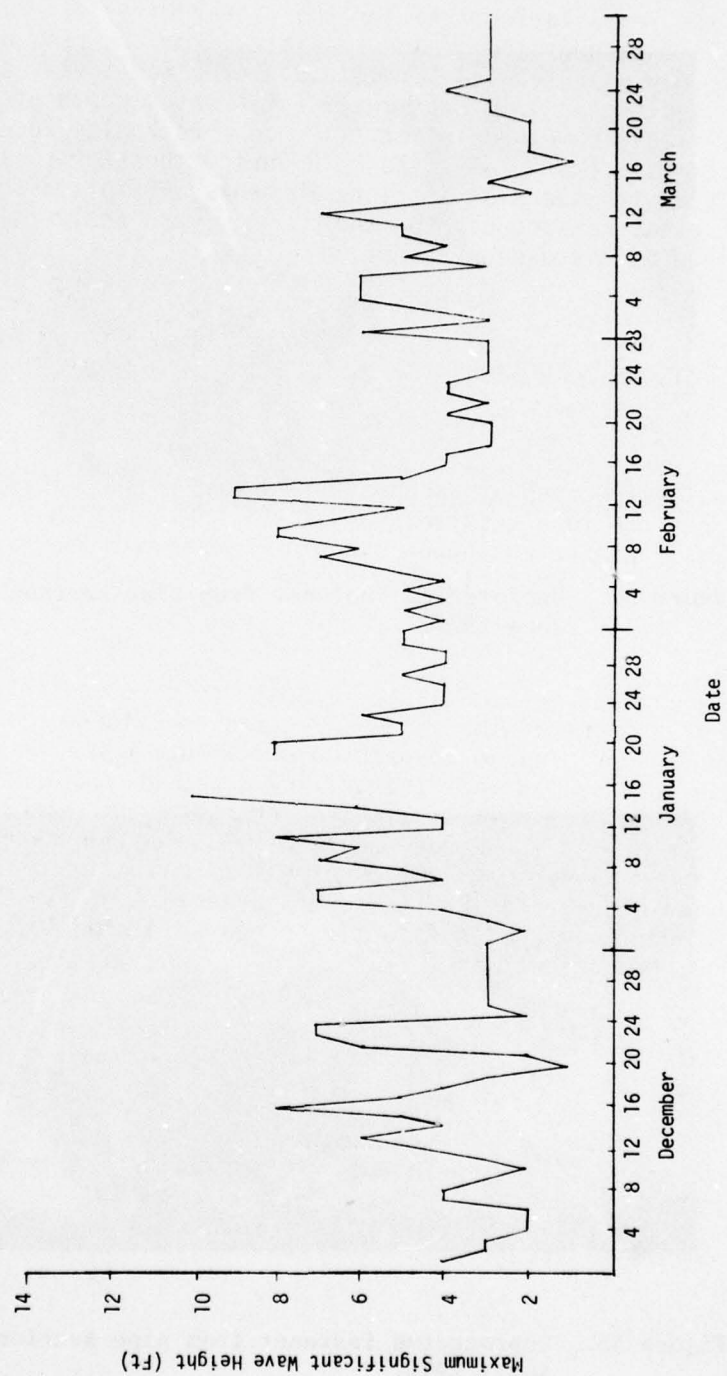
Figure 4. Significant Wave Heights

wave forces. Figure 4 shows the maximum significant wave heights in the pipe installation area for the winter of 1978. Pipe sections 2 through 10 were dislodged and separated from the rest of the installation. Only pipe section 1 remained rockbolted to the shore. All pipe sections beyond section 10 (at a water depth of 10 feet out to 42 feet) remained intact. The four rockbolts located on pipe sections 2 and 3 failed to hold during the storm. In addition, the Hi-Shear fasteners on sections 2 through 10 failed to hold these pipe halves securely together. A failure analysis of the pipe damage is discussed in section 7.

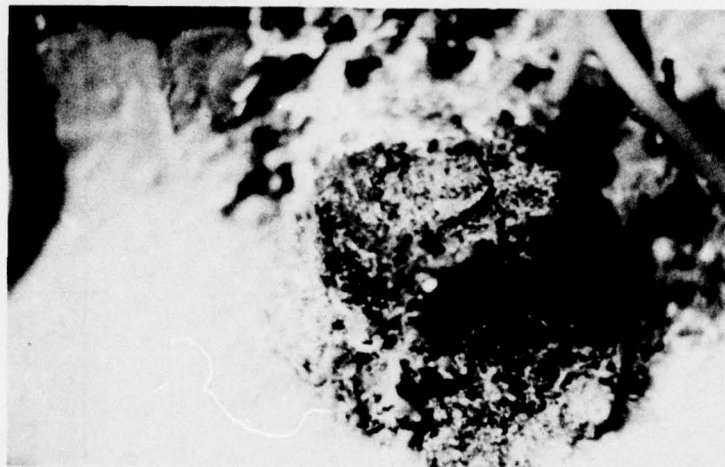
Figure 5a. Unprotected fastener from pipe section 87,
June 1977.

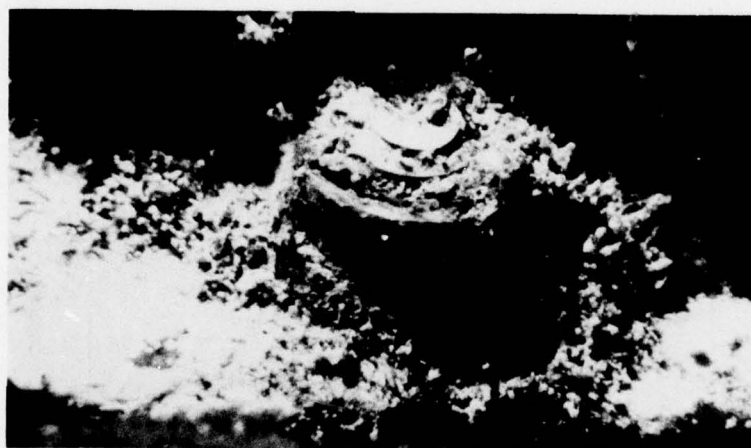
Figure 5b. Unprotected fastener from pipe section 86,
April 1978.

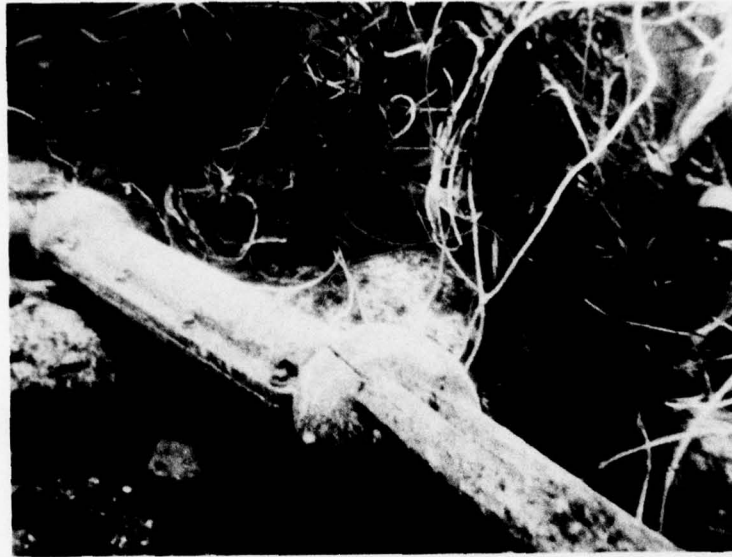
In May 1978, seven of the damaged pipe sections 2 through 10 were recovered for closer inspection and failure analysis. Figure 6 shows four views of the damaged installation and broken pipe. Note the large amount of tangled wire and armor from the exposed multi-conductor cable. Pipe sections 2 through 5 were found intact but severed completely from the rest of the installation. These sections were installed with stainless steel Hi-Shear fasteners. Close examination of these fasteners revealed that the pipe flange holes had enlarged around the fastener due to the galvanic interaction between the cast iron pipe and stainless steel fastener. Although none of the stainless fasteners were missing, the pipe halves were loose enough to allow the bell end of section 2 to open and slip off pipe section 1. Figure 7 shows the gap created between pipe

Figure 6a. Damaged pipe showing tangled multiconductive cable.

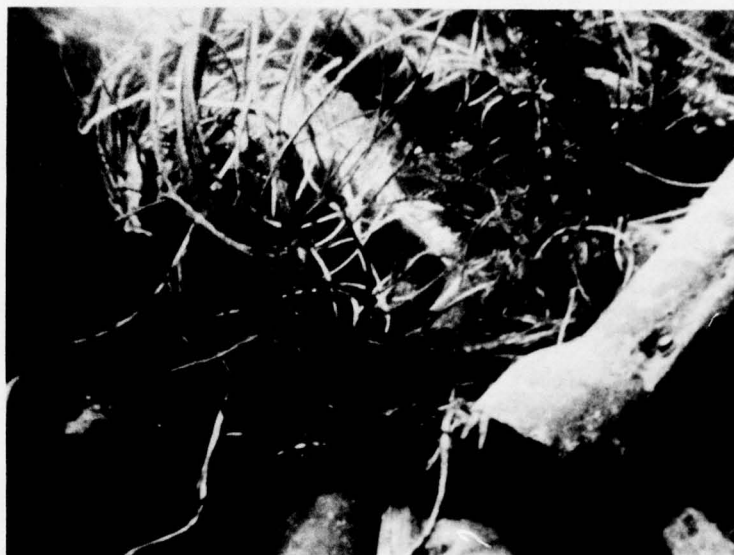
Figure 6c. Cable end extending from pipe section 11.

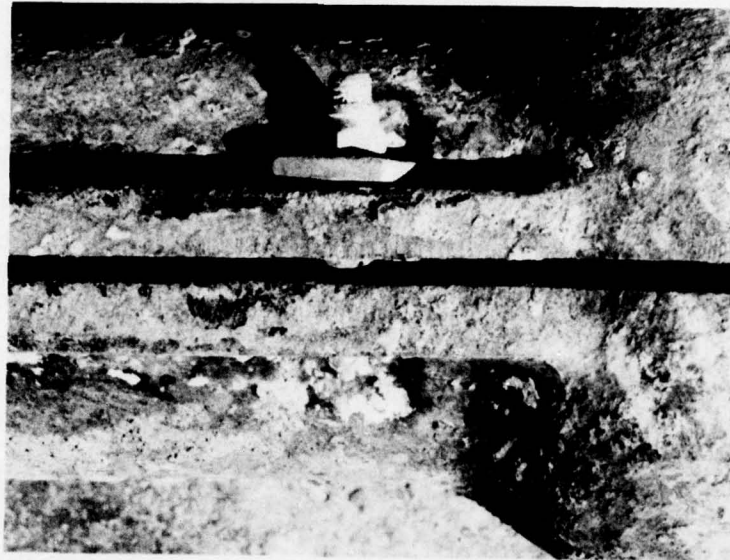
halves due to the fasteners slipping through the enlarged flange halves. The combination of corrosion and high winter wave loads was enough to cause the rockbolts to fail on pipe sections 2 and 3. Figure 8 shows the remains of two recovered rockbolts in which one had severed and one had pulled out.

Figure 7. Gap in pipe halves due to slippage of Hi-Shear stainless steel fasteners.

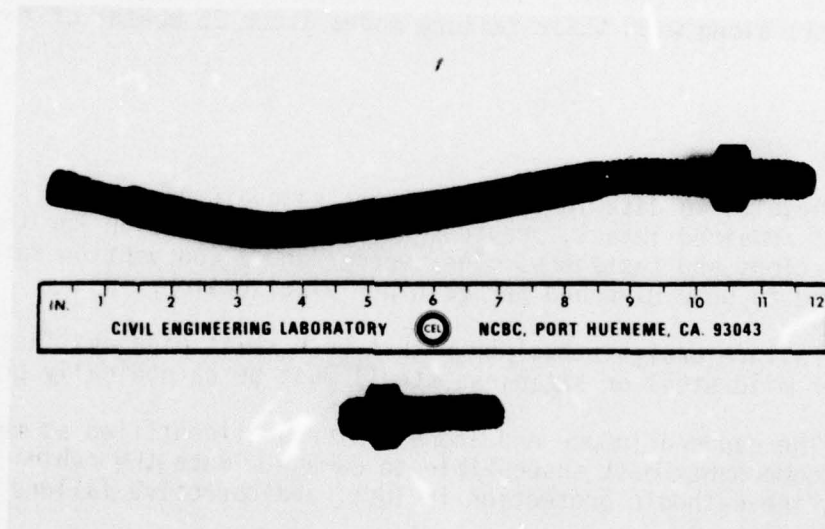
Figure 8. Recovered rockbolts.

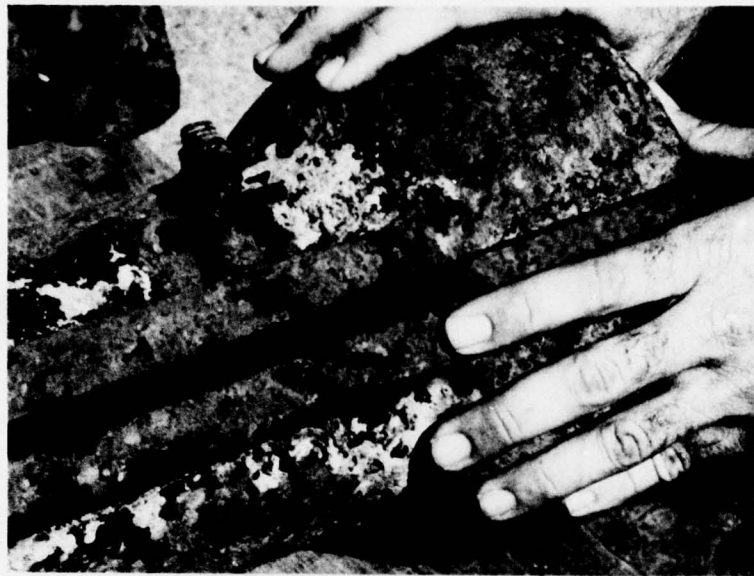
Pipe sections 6 through 10, which were installed with mild steel Hi-Shear fasteners, were found to be completely disassembled (refer to Figure 6d). The majority of these fasteners were missing from the pipe halves. Close examination of the recovered fasteners revealed that corrosion between the steel pipe and steel fastener decreased the diameter of the flared end of the fastener by about 0.1 inches. Failure occurred when these fasteners corroded enough to slip through the pipe flange holes. Figure 9 shows the mode of failure for the mild steel Hi-Shear fasteners.

Figure 9. Corroded Hi-Shear steel fasteners slipping through the pipe flange.

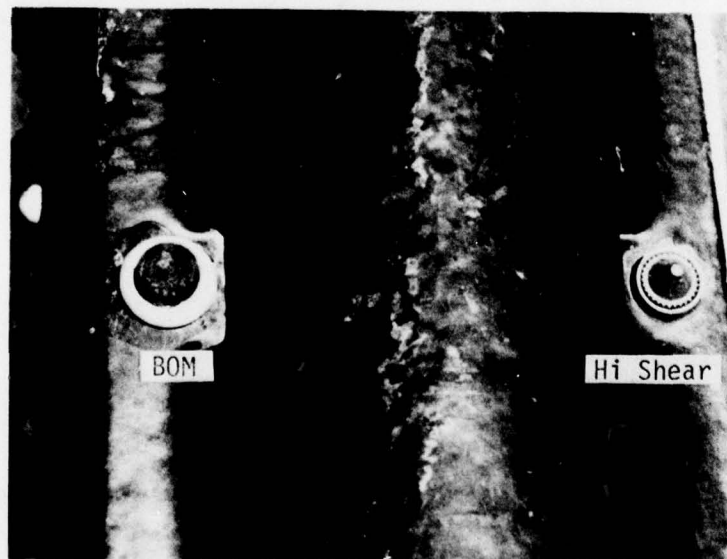
The only fasteners that remained intact were the BOM fasteners which were installed beginning with Section 11. These fasteners have enlarged swaged ends, which resist slippage due to corrosion. Figure 10 shows a comparison of the enlarged swaged end of a BOM fastener with the swaged end of a Hi-Shear fastener.

Figure 10. Comparison of the swaged end of a BOM and Hi-Shear fastener.

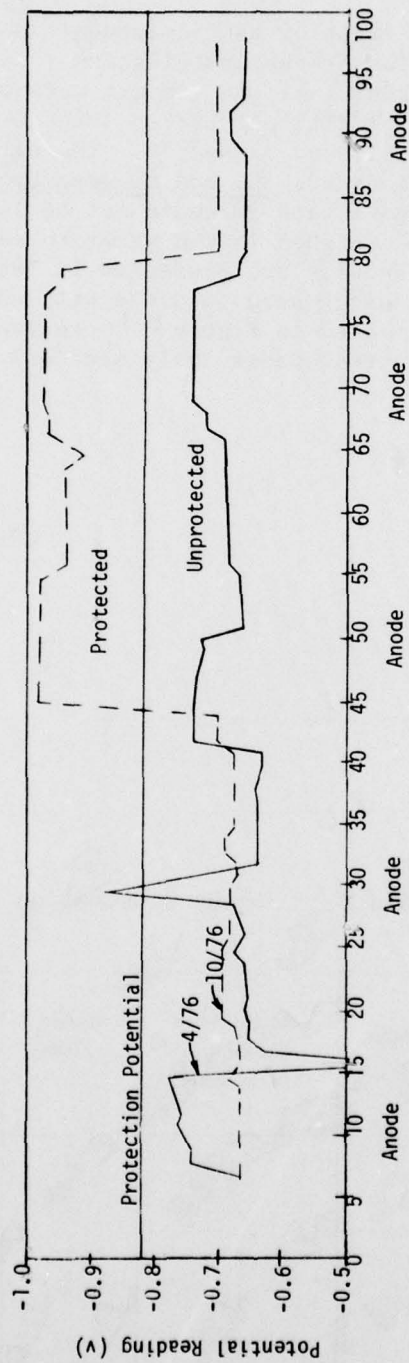
Figure B-1. Cathodic Protection Potential

Galvanic potential readings were obtained with an underwater voltmeter; the results are presented in Figure B-1. Because of the numerous broken jumpers and disconnected anodes, only sections 45 through 78 are being protected.
